Appendix D: Phase 1 System Improvement Approaches

Wayne County Rouge Valley Sewage Disposal System

Floodplain Manhole Inspection Results Long Term Corrective Action Plan – Phase 1 (Task G) Floodplain Manhole Inspection

Rouge Valley Sewage Disposal System Phase 1: Floodplain Manhole Inspection March 8, 2016

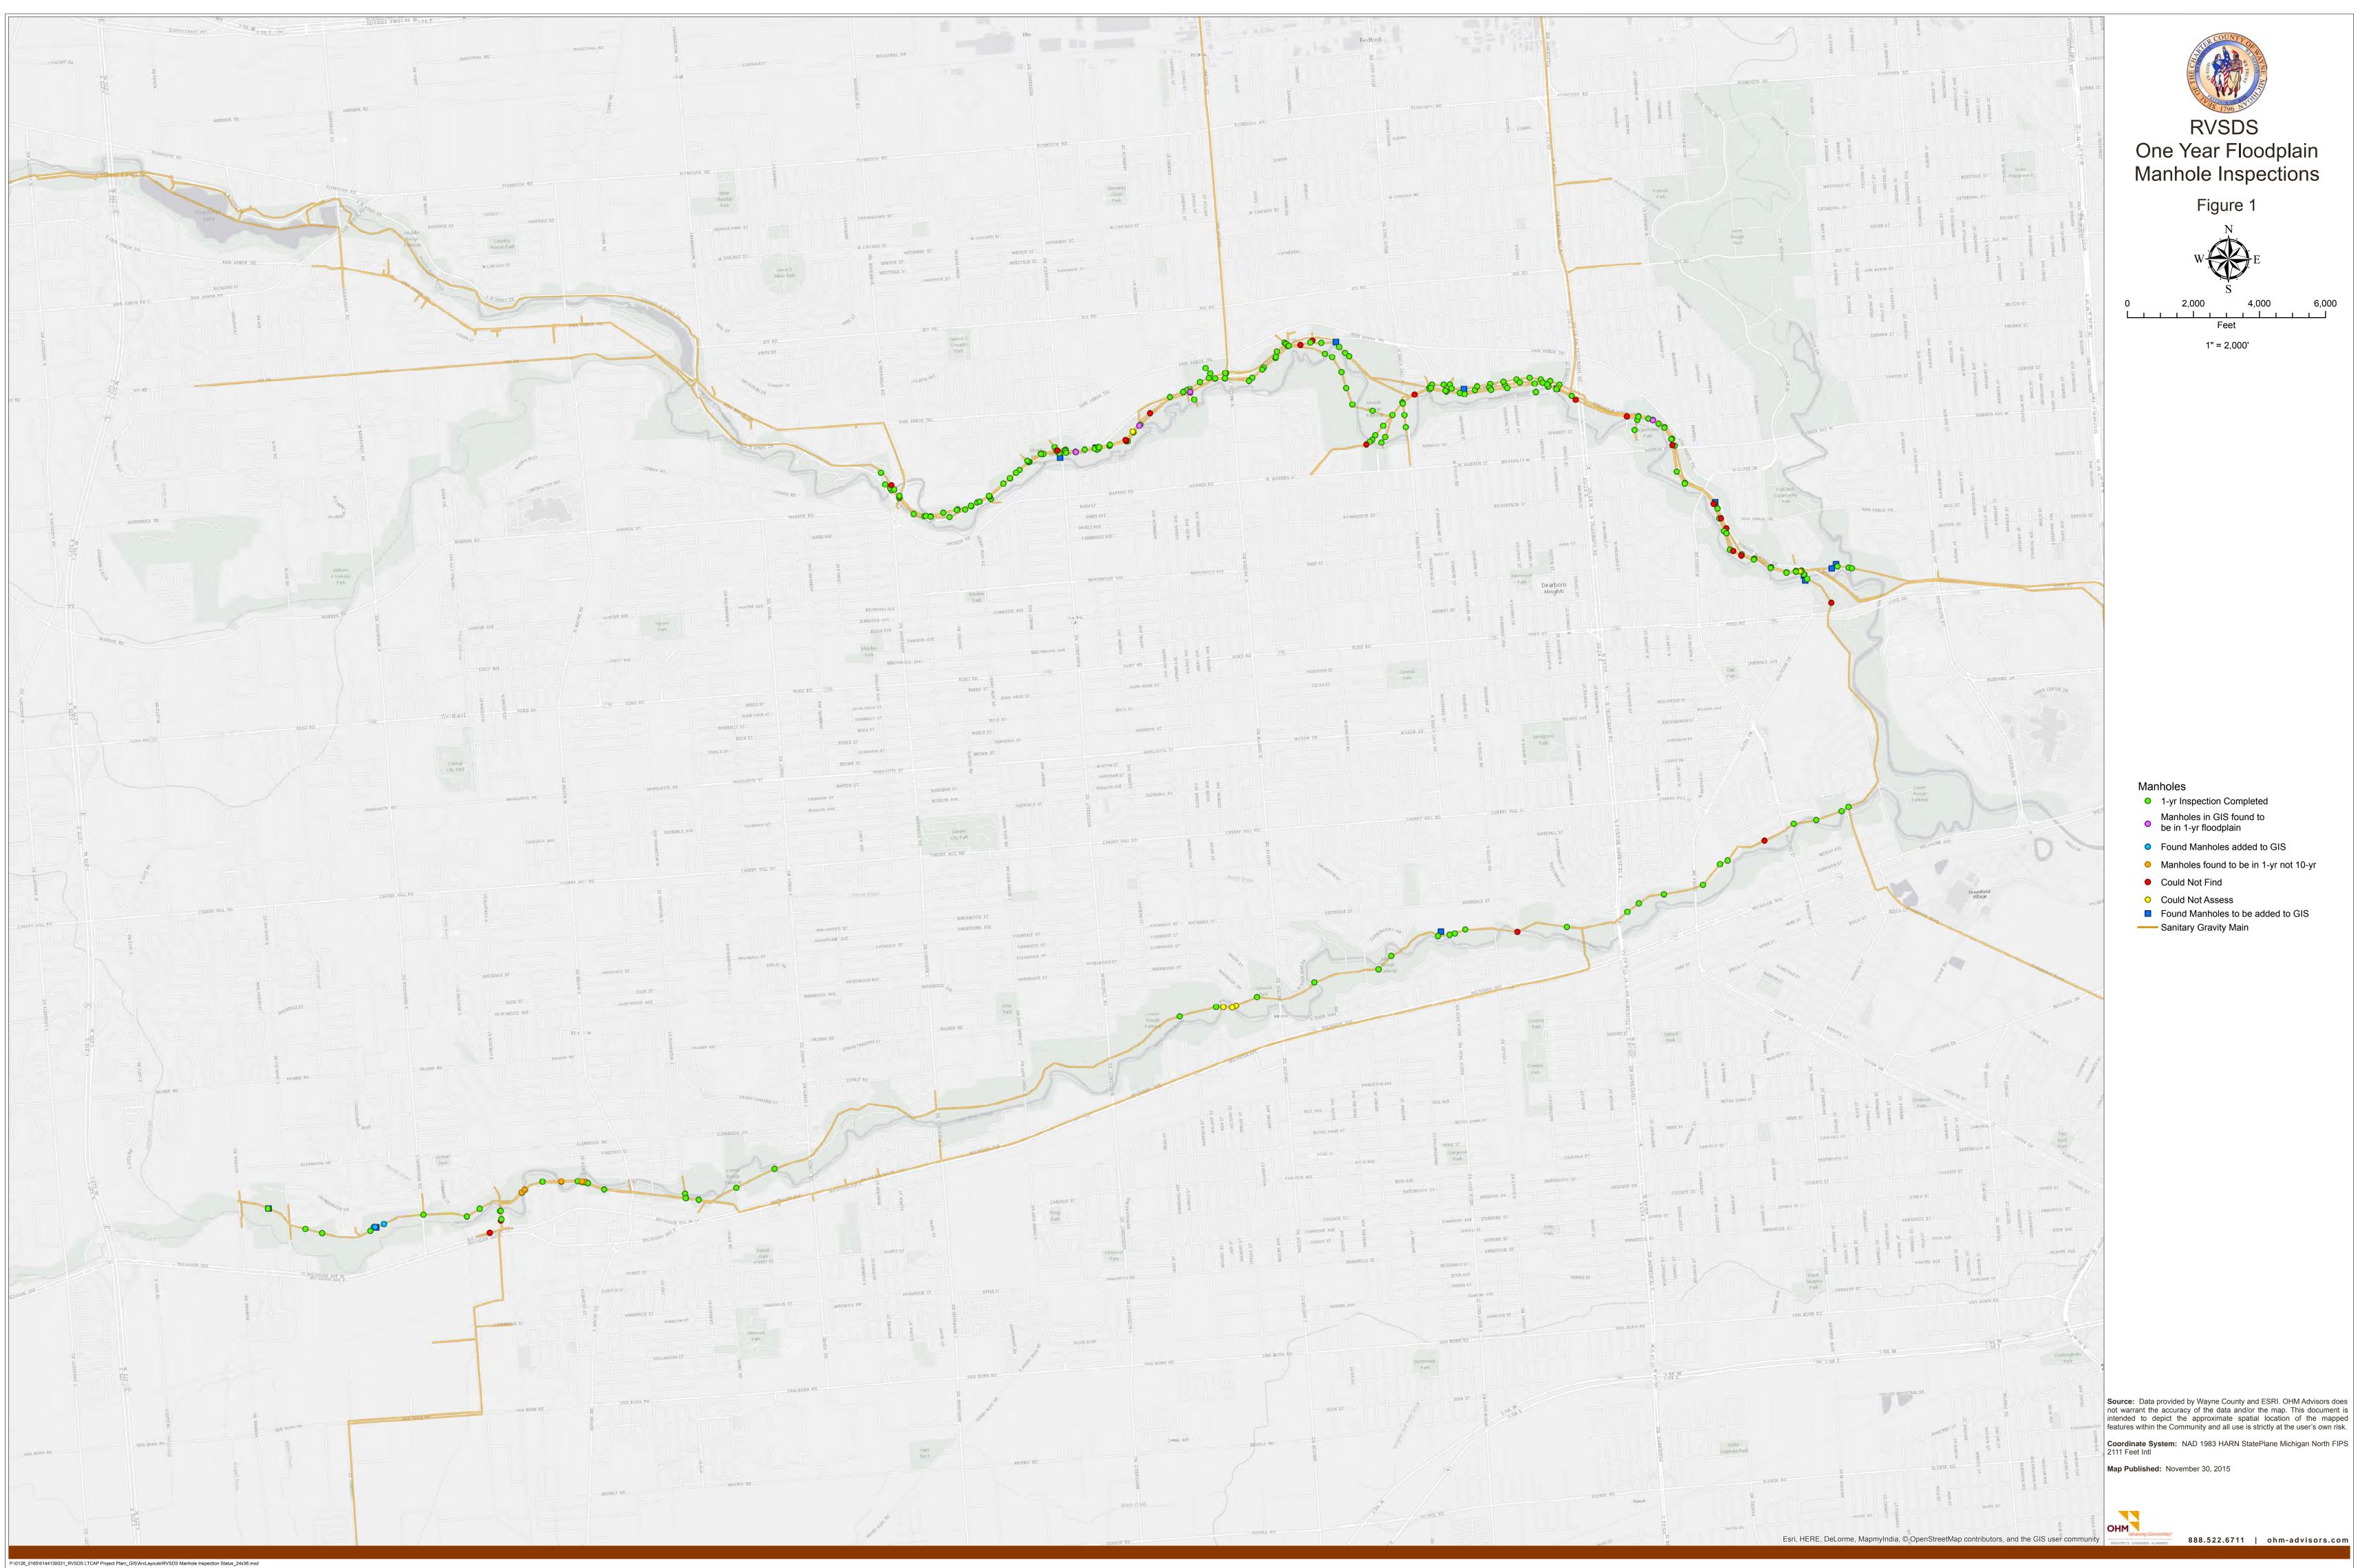
Appendix A: Data Collection

259 manholes were identified as being below the 1-year floodplain and were inspected in late 2015 along the Middle and Lower Rouge interceptors. The survey crew used GIS Collector (mobile application) to keep inventory of the manholes assessed. In addition to the original identified manholes, 26 more manholes with rim elevations below the 1-year floodplain were found, identified, and inspected as 1-year floodplain structures. Of these, four were not identified as 1-year floodplain manholes from ASI's list, but were in Wayne County's GIS database. An additional four were found by the field crew that where not in the current GIS database. Five structures, which were identified by ASI to be in the 10-year floodplain, were actually found to be in the 1-year floodplain. These thirteen manholes have already been updated in the RVSDS GIS database by OHM Advisors. Thirteen more manholes in the 1-year floodplain were found by the field crew that were also not in GIS; however, these still need to be added to the database.

A map of all locations inspected is provided in Appendix A. Additionally, imagery (including hyperlinks to images) for each manhole found and inspected can be found in Appendix A. No more

In general, the RVSDS interceptor manholes within the 1-year floodplain were found to have significant maintenance deficiencies that would increase the likelihood of wet weather inflow. The most common deficiency, missing gasket/bolts, was observed in 26% of the inspected manholes. In these cases, the missing bolts were observed in close proximity to the manhole, which suggests that the manhole was previously removed and the bolts were not replaced. Several manholes in the

vicinity of the Warren Valley Golf Course clubhouse were noted to have missing bolts, which suggests that golf course staff may have removed these manholes in an attempt to dewater the area around the clubhouse during previous wet weather events. In total, 51% of the inspected manholes had deficiencies.

It is recommended that Wayne County addresses the following manholes for improvements in Phase 1 of the LTCAP, in the order presented below.

- Replace the missing manhole lid for RVI 13-23.
- Address manholes with multiple components in poor condition or missing below in the 1year and 2-year floodplain.
- Address manholes with only one component in poor condition or missing. First, focus on the manholes in the 1-year and 2-year floodplain with missing gaskets and bolts and then move onto manholes with poor seals and frame.
- Use tamper-proof bolts for future manhole improvements. Focus the use of tamper-proof bolts in high-risk areas, including the Warren Valley Golf Course and other manholes in easily-accessible areas. In the long term, all 1-year floodplain manholes should have tamper-proof bolts.

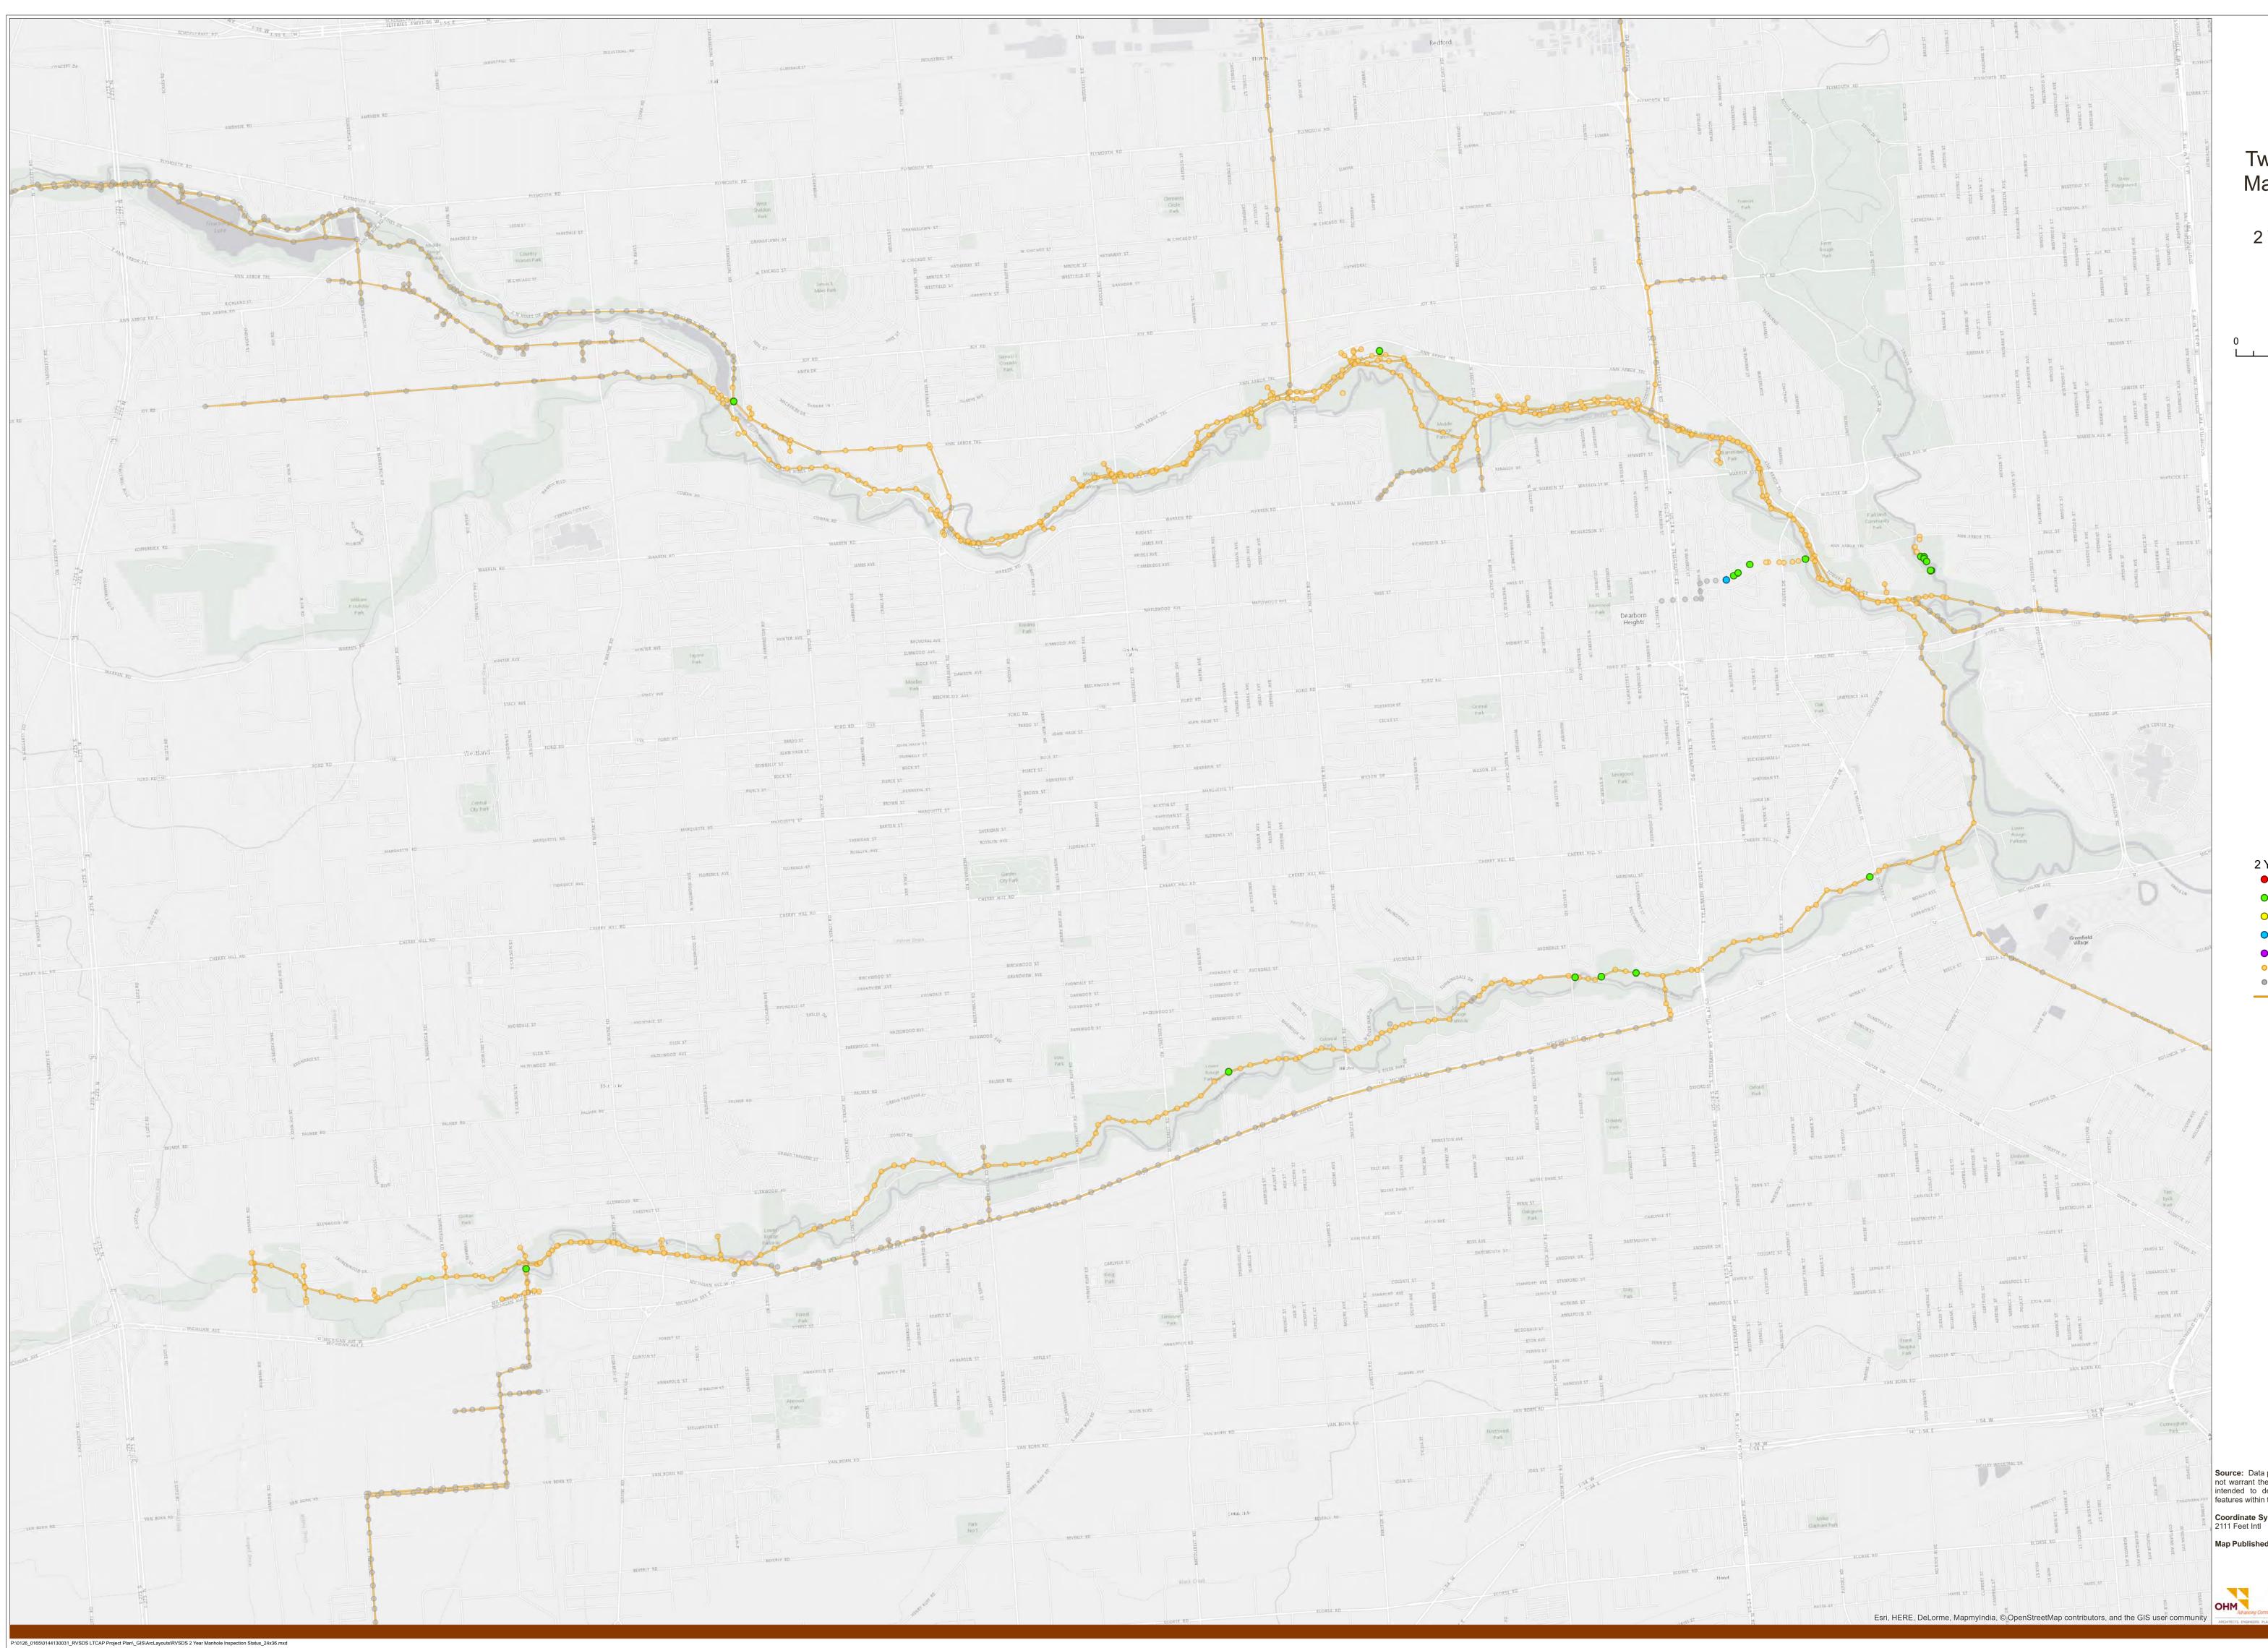
Appendix C: 2-year Floodplain Manhole Data

A map of all locations inspected is provided in Appendix C. Additionally, image (including hyperlinks to images) for each manhole found and inspected can be found in Appendix C. No more manholes need to be assessed in the 2-year floodplain.

All 2-year floodplain manholes inspection data were analyzed similarly to the 1-year floodplain manholes. The analysis was based on manhole components that are missing, are in poor condition, or pose a potential threat to public safety. These components include the cover, gasket/bolts, and adjustment ring and frame. Table 4 lists the manholes with deficient characteristics that could negatively impact the RVSDS interceptor during wet weather events, and Table 5 list the multiple combinations of rehabilitation needed per manhole. Appendix C includes a more comprehensive table listing each component with the structure ID and observed characteristics of each manhole.

Additionally, the data collected were compared to improvements made during 2010 and 2011 as part of the RVSDS STCAP. Only one manhole in the 2-year floodplain, RVI 14-05, was found to have had new gasket/bolts replaced in 2011 and is now in poor condition.
