Riparian Corridor Project Profile

Brownstown Creek Streambank Stabilization Project

Brownstown Streambank Stabilization Project

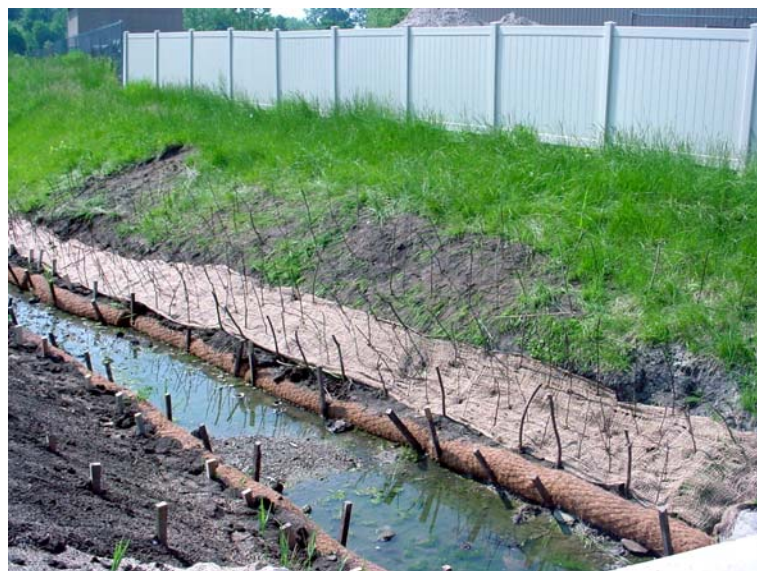
The southern streambank is stabilized with live stakes and native wildflower seed (M. Best)

The Lake Erie Watersheds Riparian Corridor Management Sub-Committee provided technical advice for the project. The WCDOE and Brownstown Township prepared the site by re-grading the bank, removing turf grass and delivering topsoil. On June 4th, 2004, a Riparian Corridor Management Workshop, Hand-on Technique Training Workshop and Demonstration Project was held at the site. This event included a session of where participants received information on hands-on stream bank stabilization technique training, then the participants completed the demonstration project. 10 participants stabilized the eroding streambank by installing 60 linear feet of Live Fascines and 60 linear feet of live stakes (Both are soil bioengineering stabilization techniques.) The toe of each slope's bank were stabilized with coir logs. The top of each slope was planted with grasses and native plants to create a new buffer area.

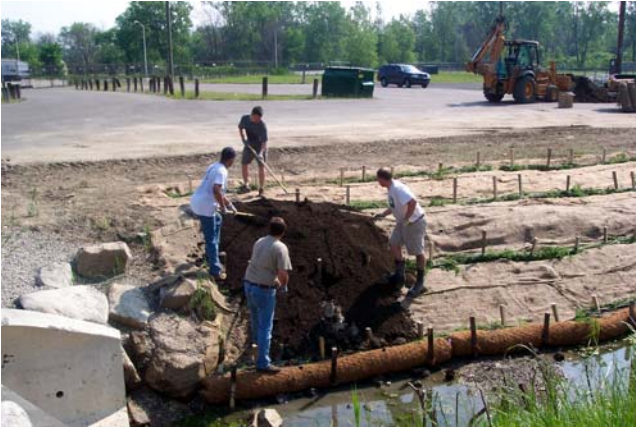
Volunteers cover the fascines with topsoil . (Picture - S. Harbour)

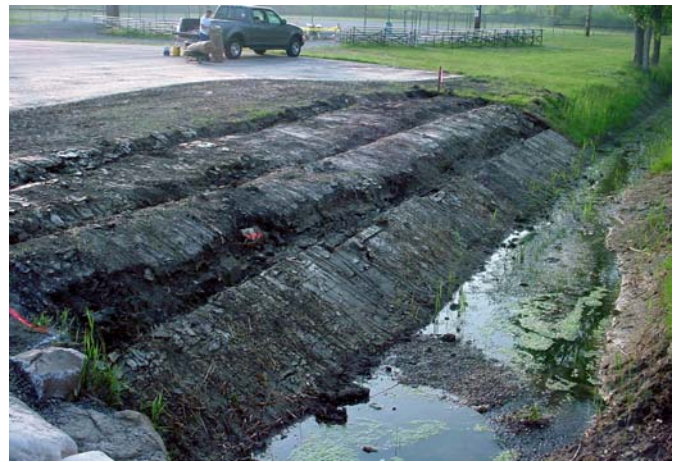
Riparian area before work was done. (Picture - M. Best)

The Brownstown Township Hall is adjacent to the Brownstown Creek. It is a multi-use area with baseball fields, parking and municipal buildings. Much of the area is mowed, providing little in the way of a buffer zone for the creek. Streambanks where the lawn is mowed up to the waters edge are eroding.

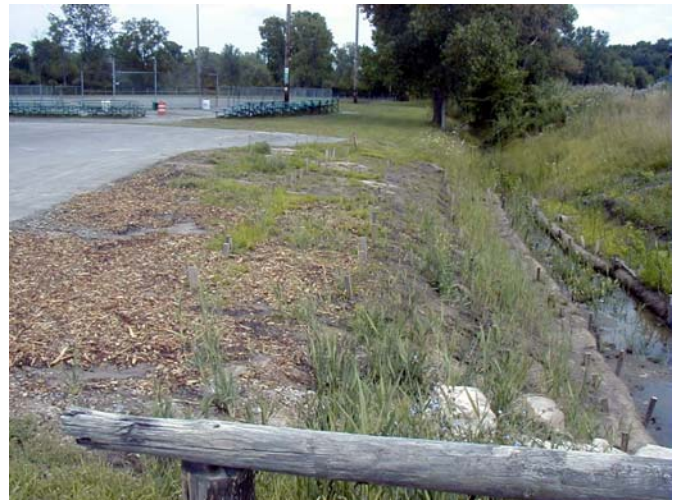
Riparian area two months later . (Picture - M. Best)
