Riparian Corridor Project Profile

Quick Park Riparian Area Stabilization Project

Quick Park Streambank Stabilization Project

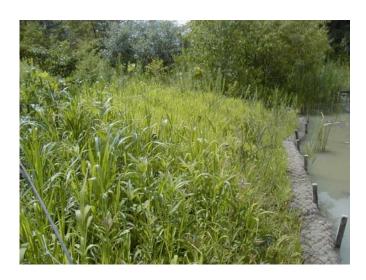
Riparian area three months later . (Picture - M. Best)

environmental group, the Stream Team, completed the demonstration project. Over 40 participants stabilized the eroding streambank by installing 10 linear feet of Live Fascines, 10 linear feet of Brushmattress and 10 linear feet of live posts and stakes (All three are soil bioengineering stabilization techniques.) The toe of the slope was stabilized with coir logs. The top of each slope was planted with grasses and native plants to create a new buffer area.
